Case 334 : Narrative

Case Vehicle (A): 2000 GMC
Type: Sierra 1500, 4 x 4, 2-door pickup
Driver: 21-year-old male
CDC: 12-FDEW-2, 00-TPZN-2

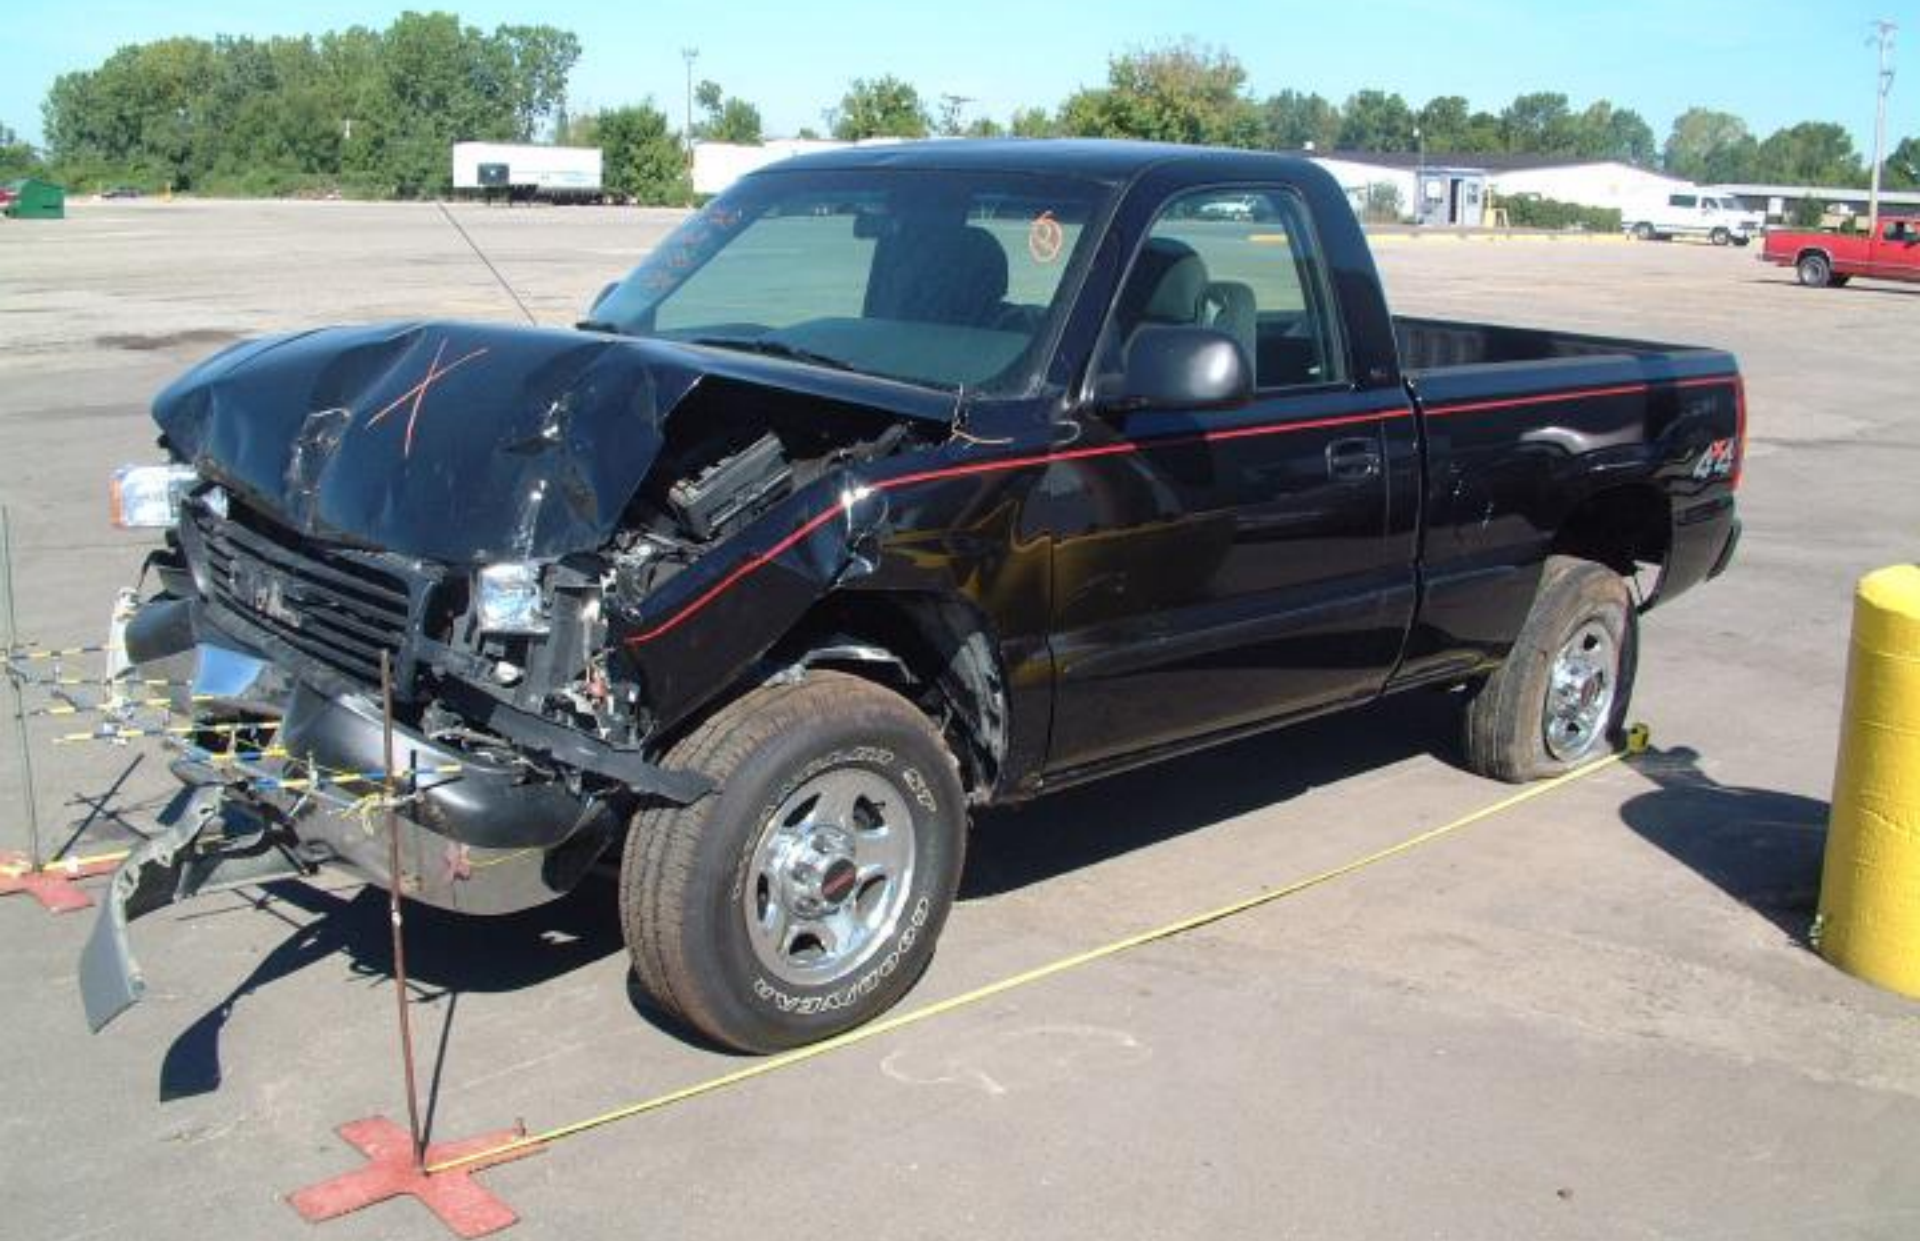
[19](#) On the left side, the left fender was crushed rearward and the forward portion was buckled down, and [20](#) the left rear tire was flat and the rim was dented. The left-side door was closed and operational, and there was no damage to the left-

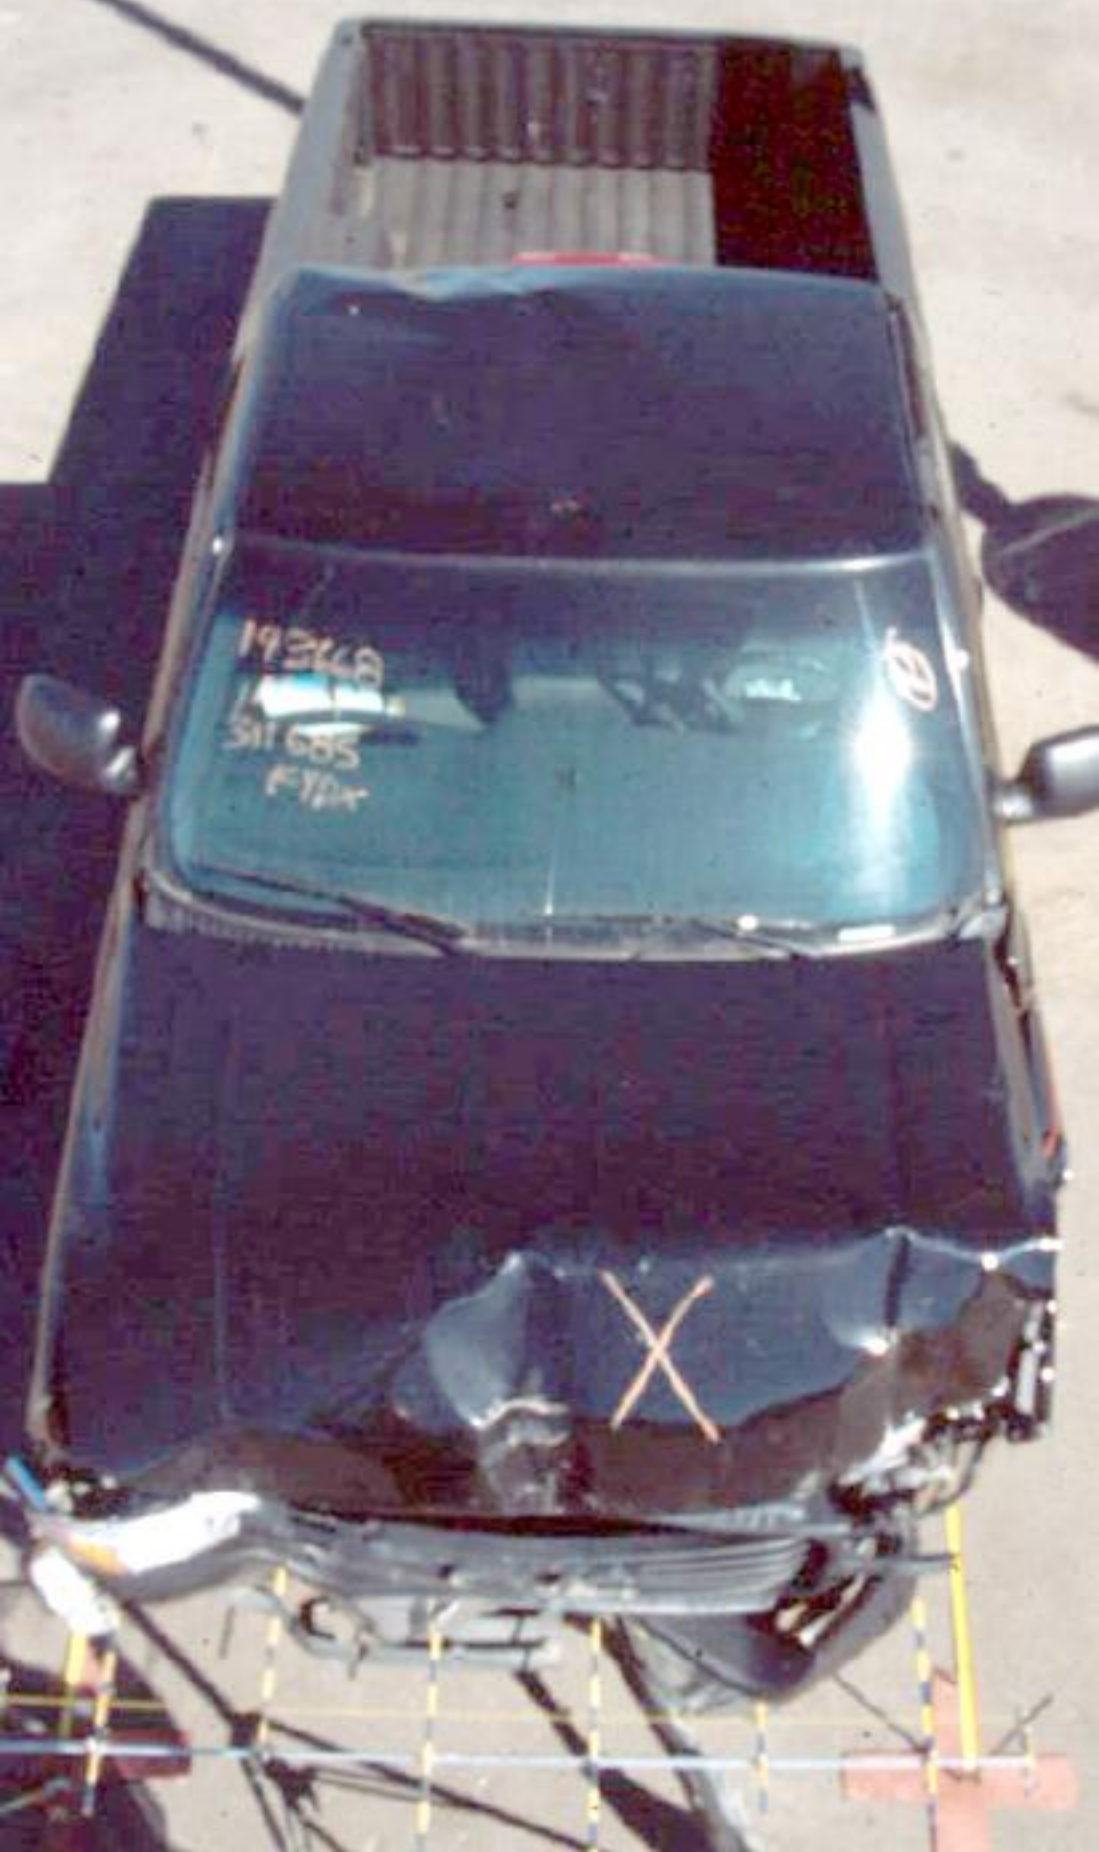
side glazing. [21](#) There was no other left-side damage and there was no measurable change to the left wheelbase.

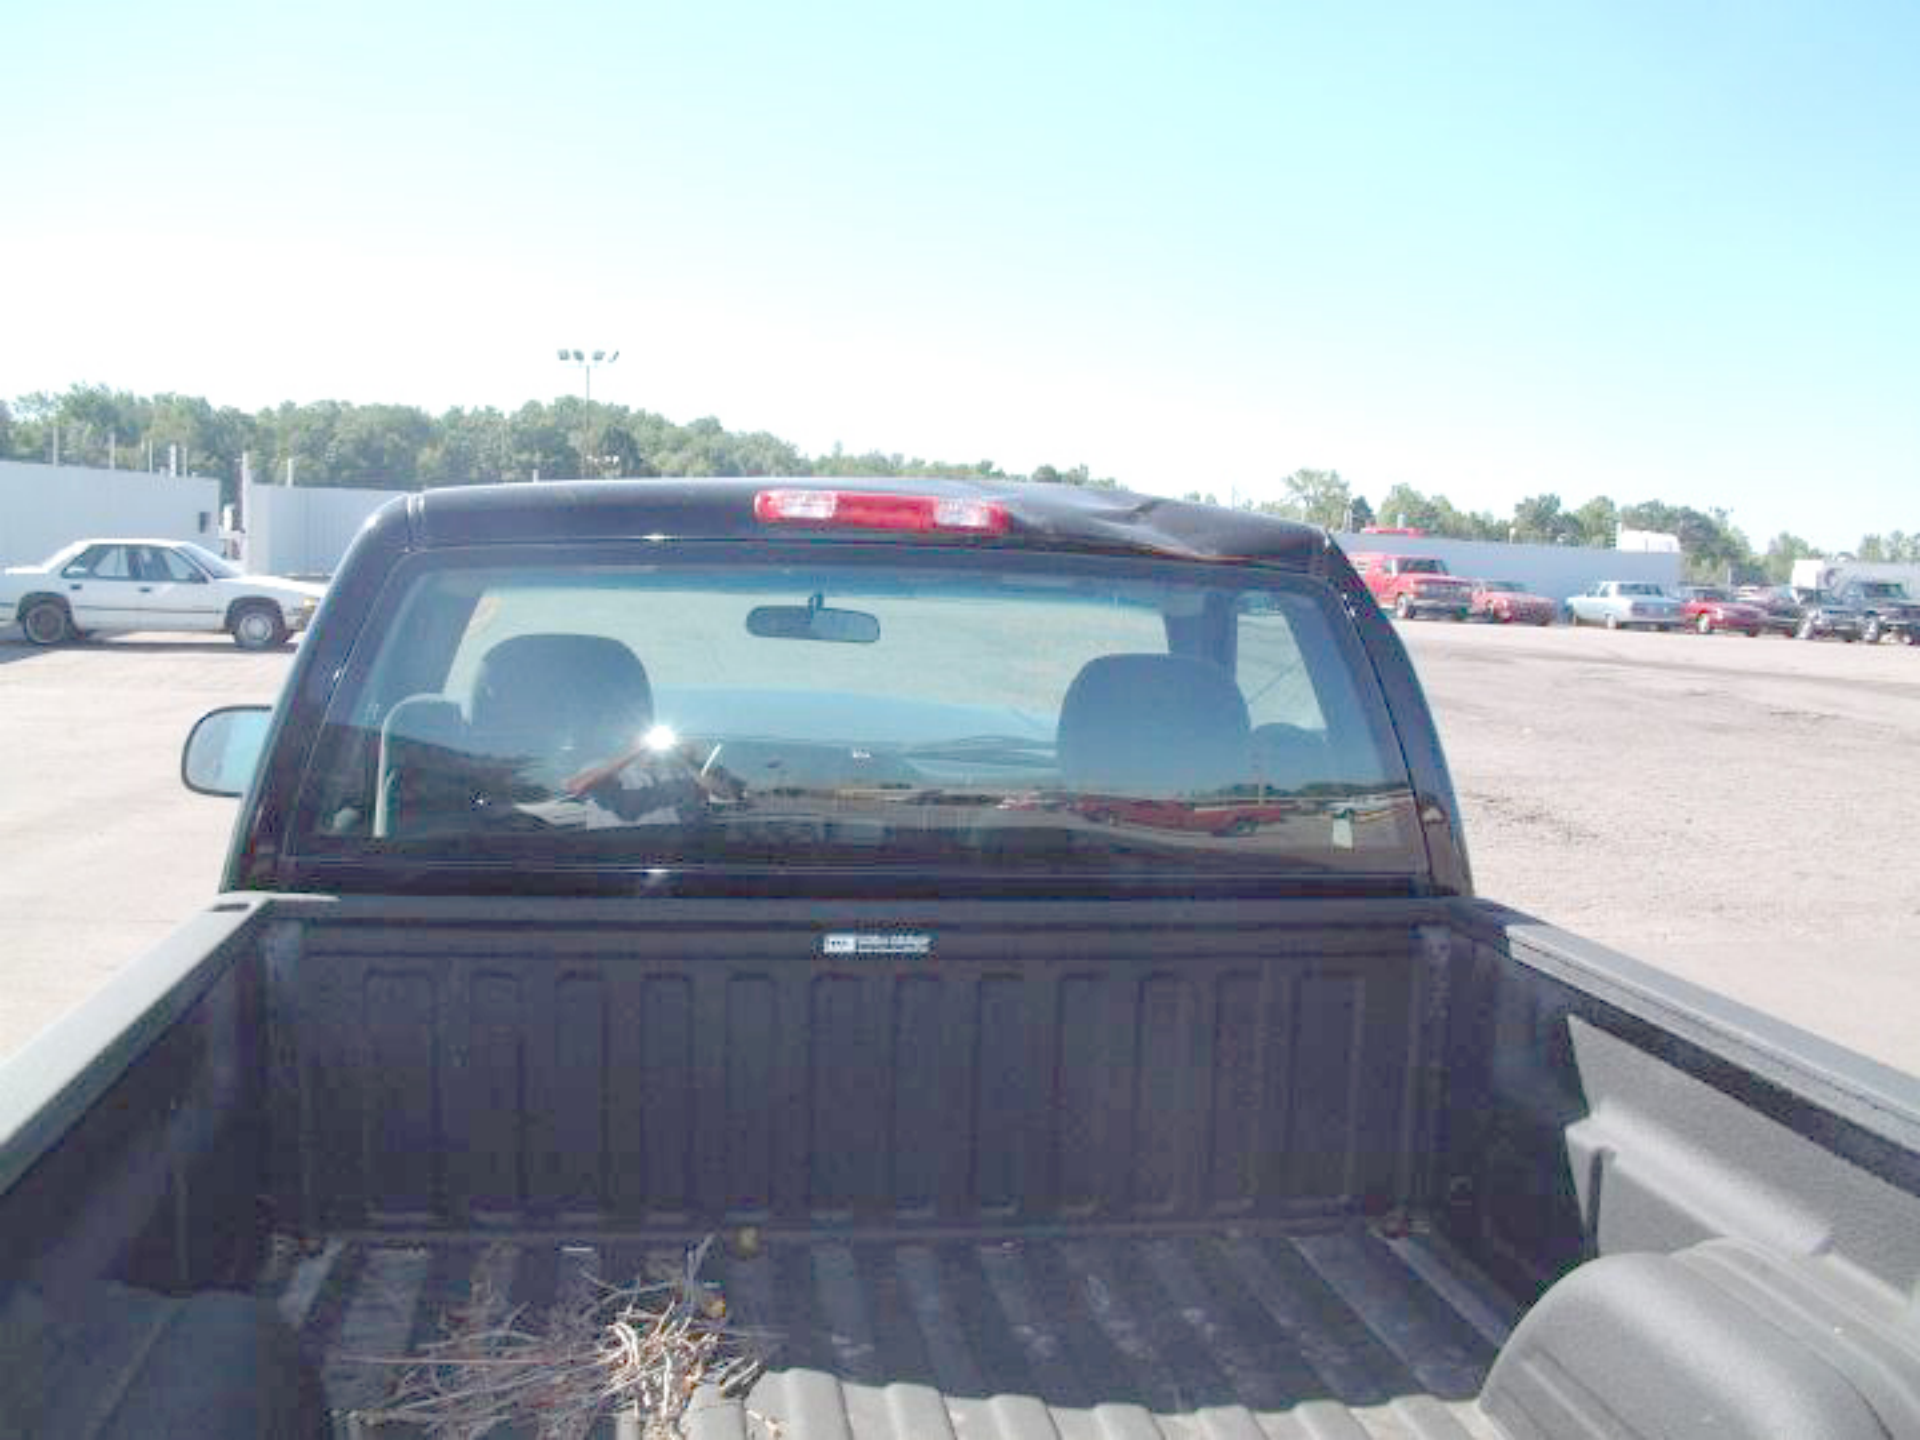
[22](#) In the rear, the backlight header was crushed down, but the backlight glazing was not damaged. There was no other damage to the rear of the vehicle.

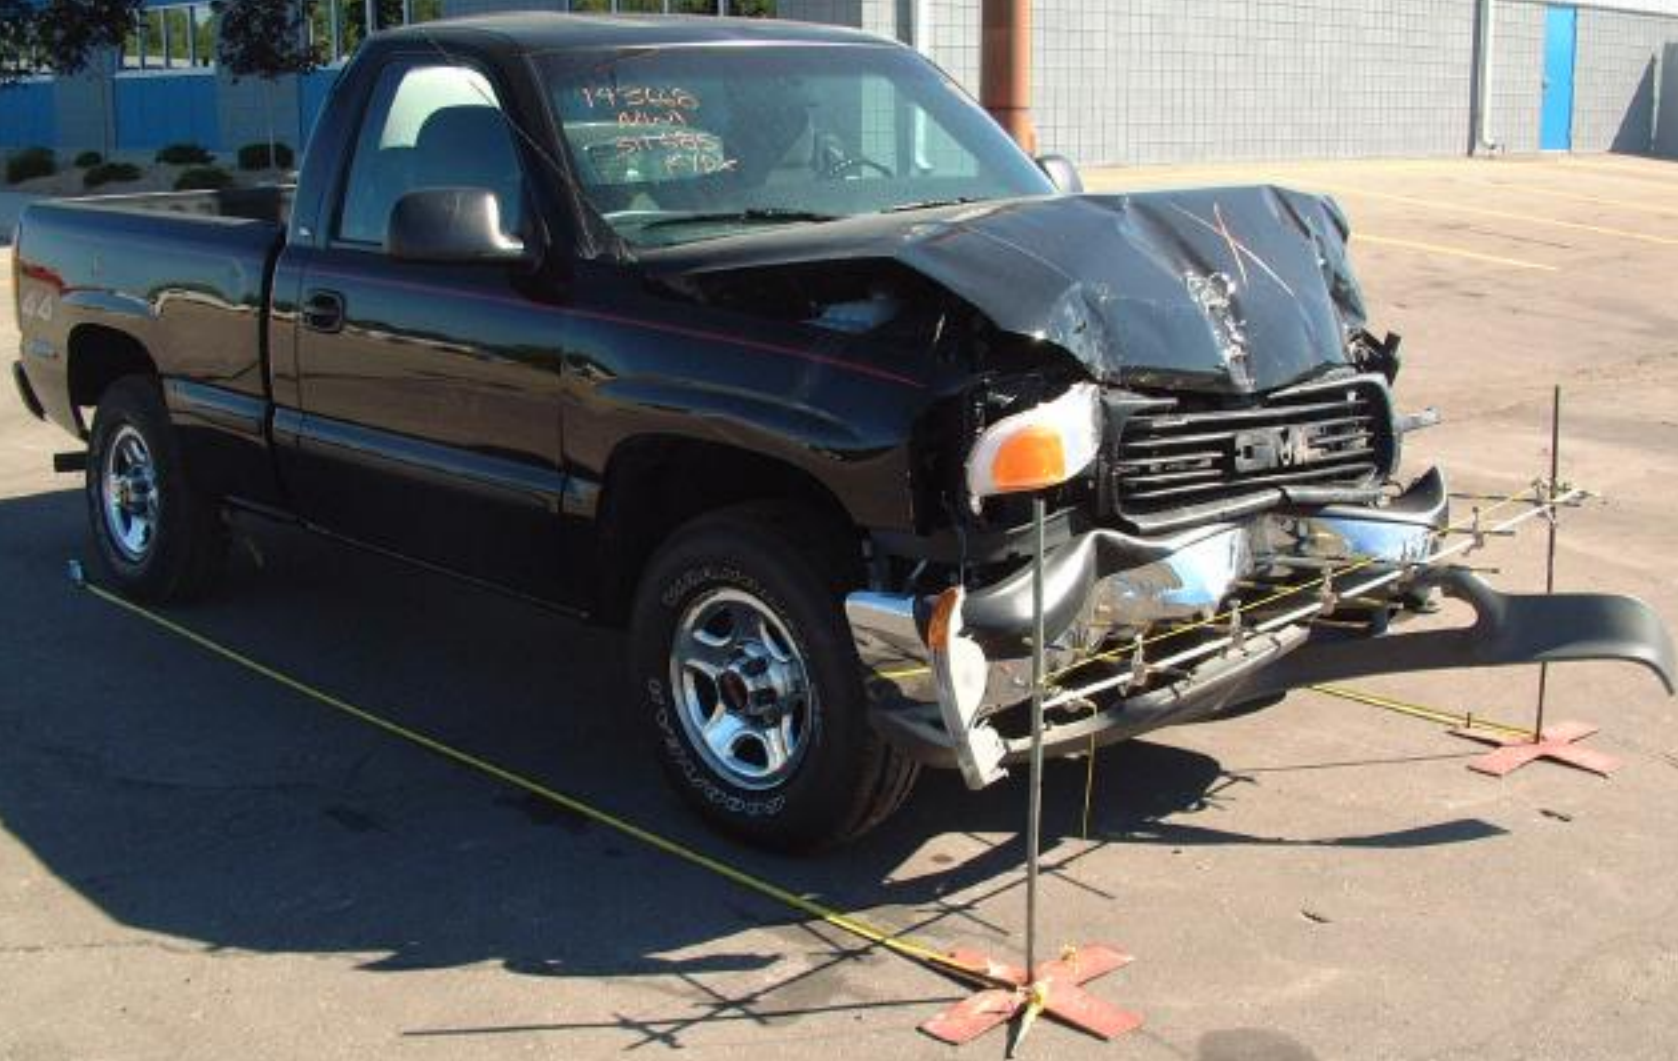
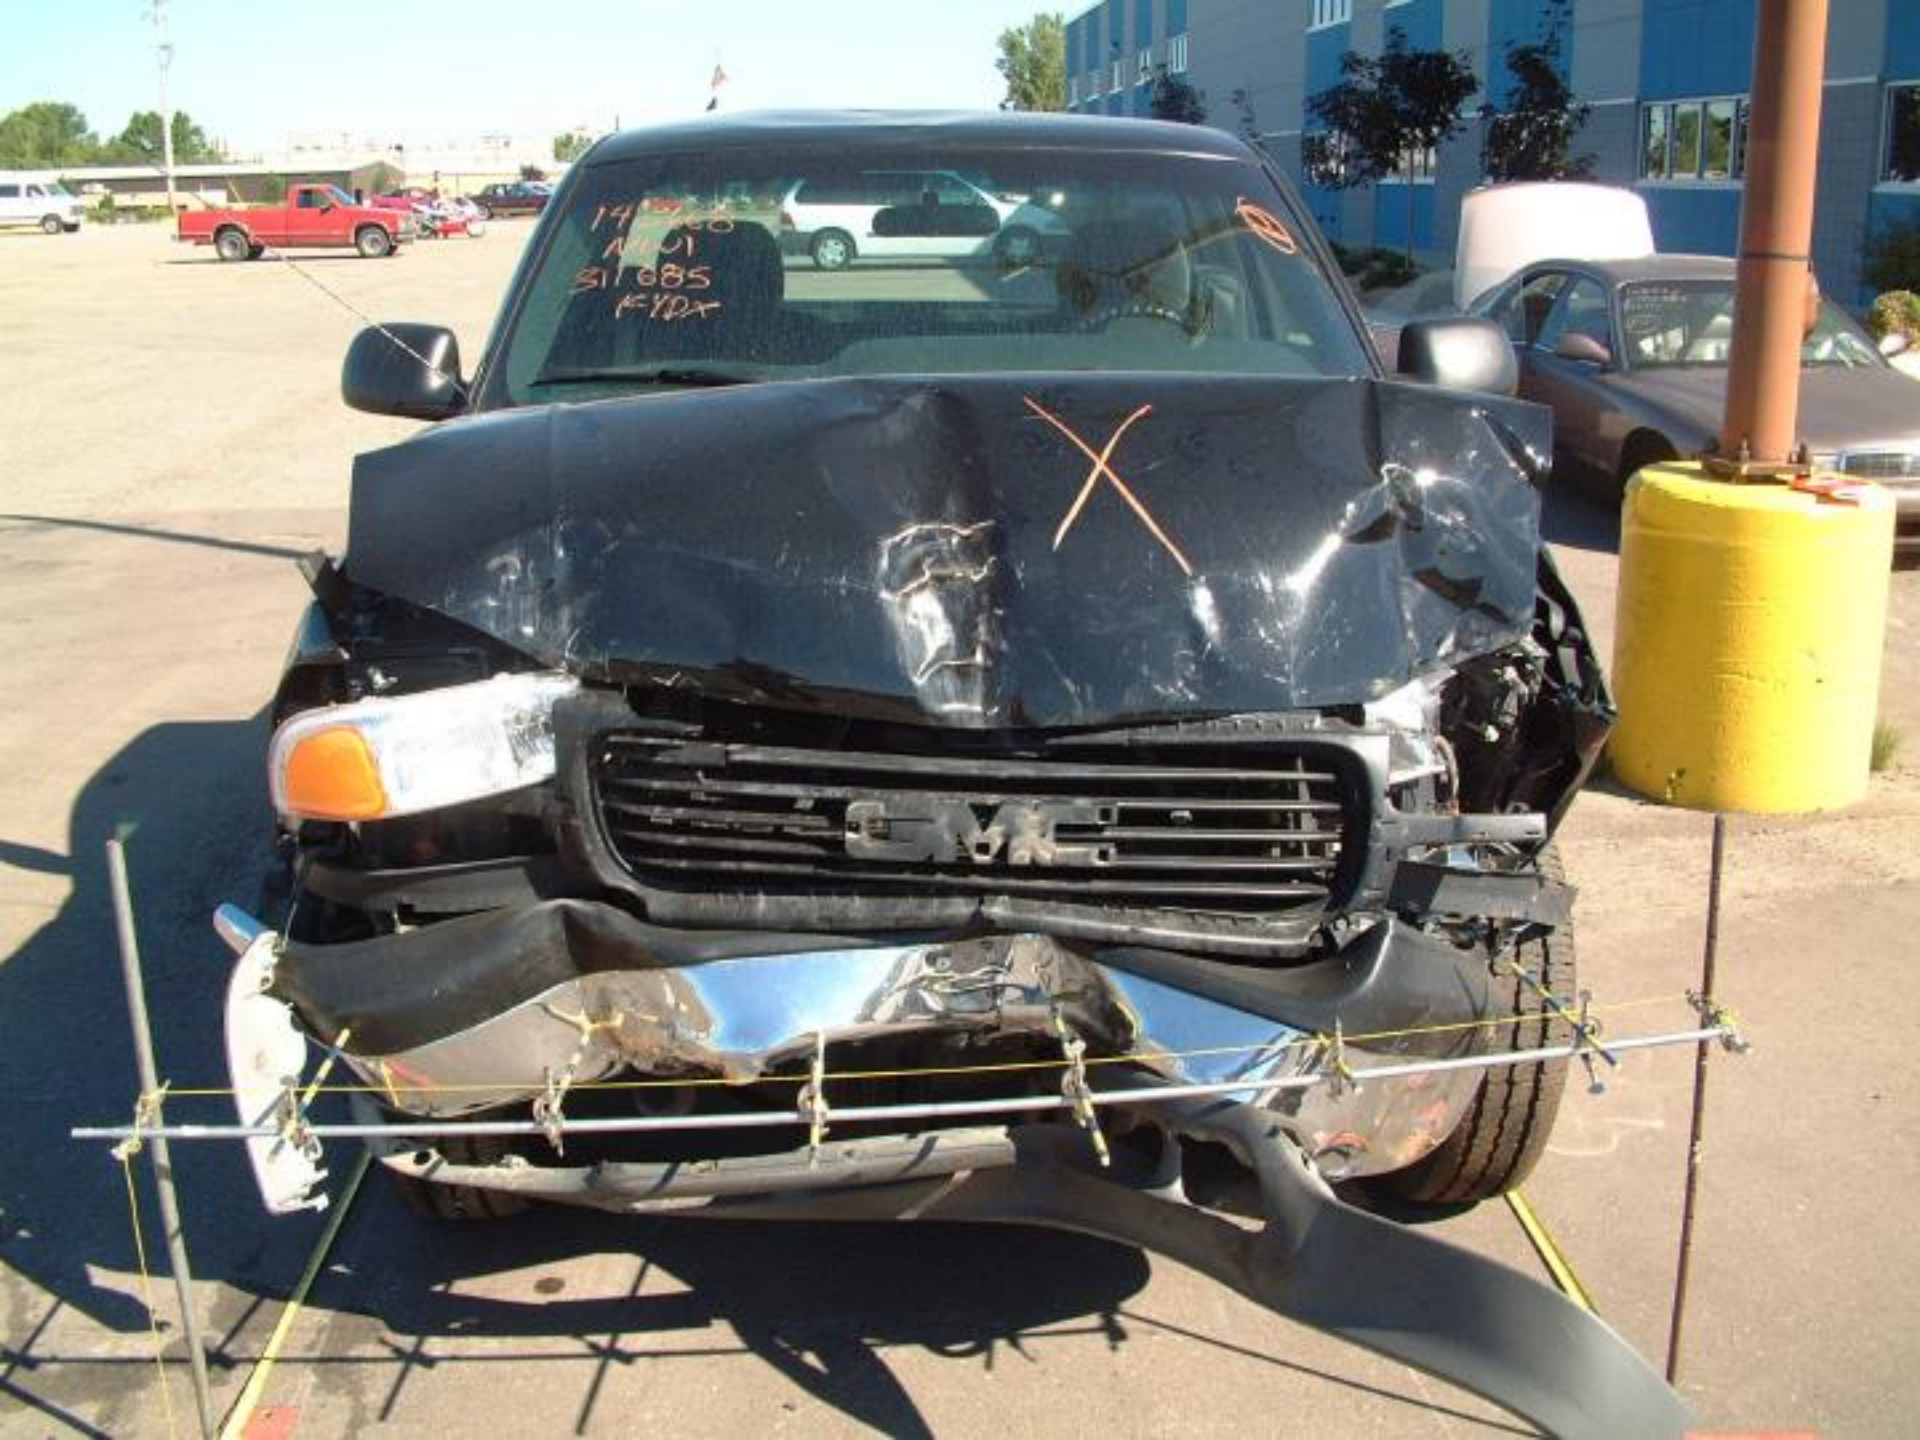
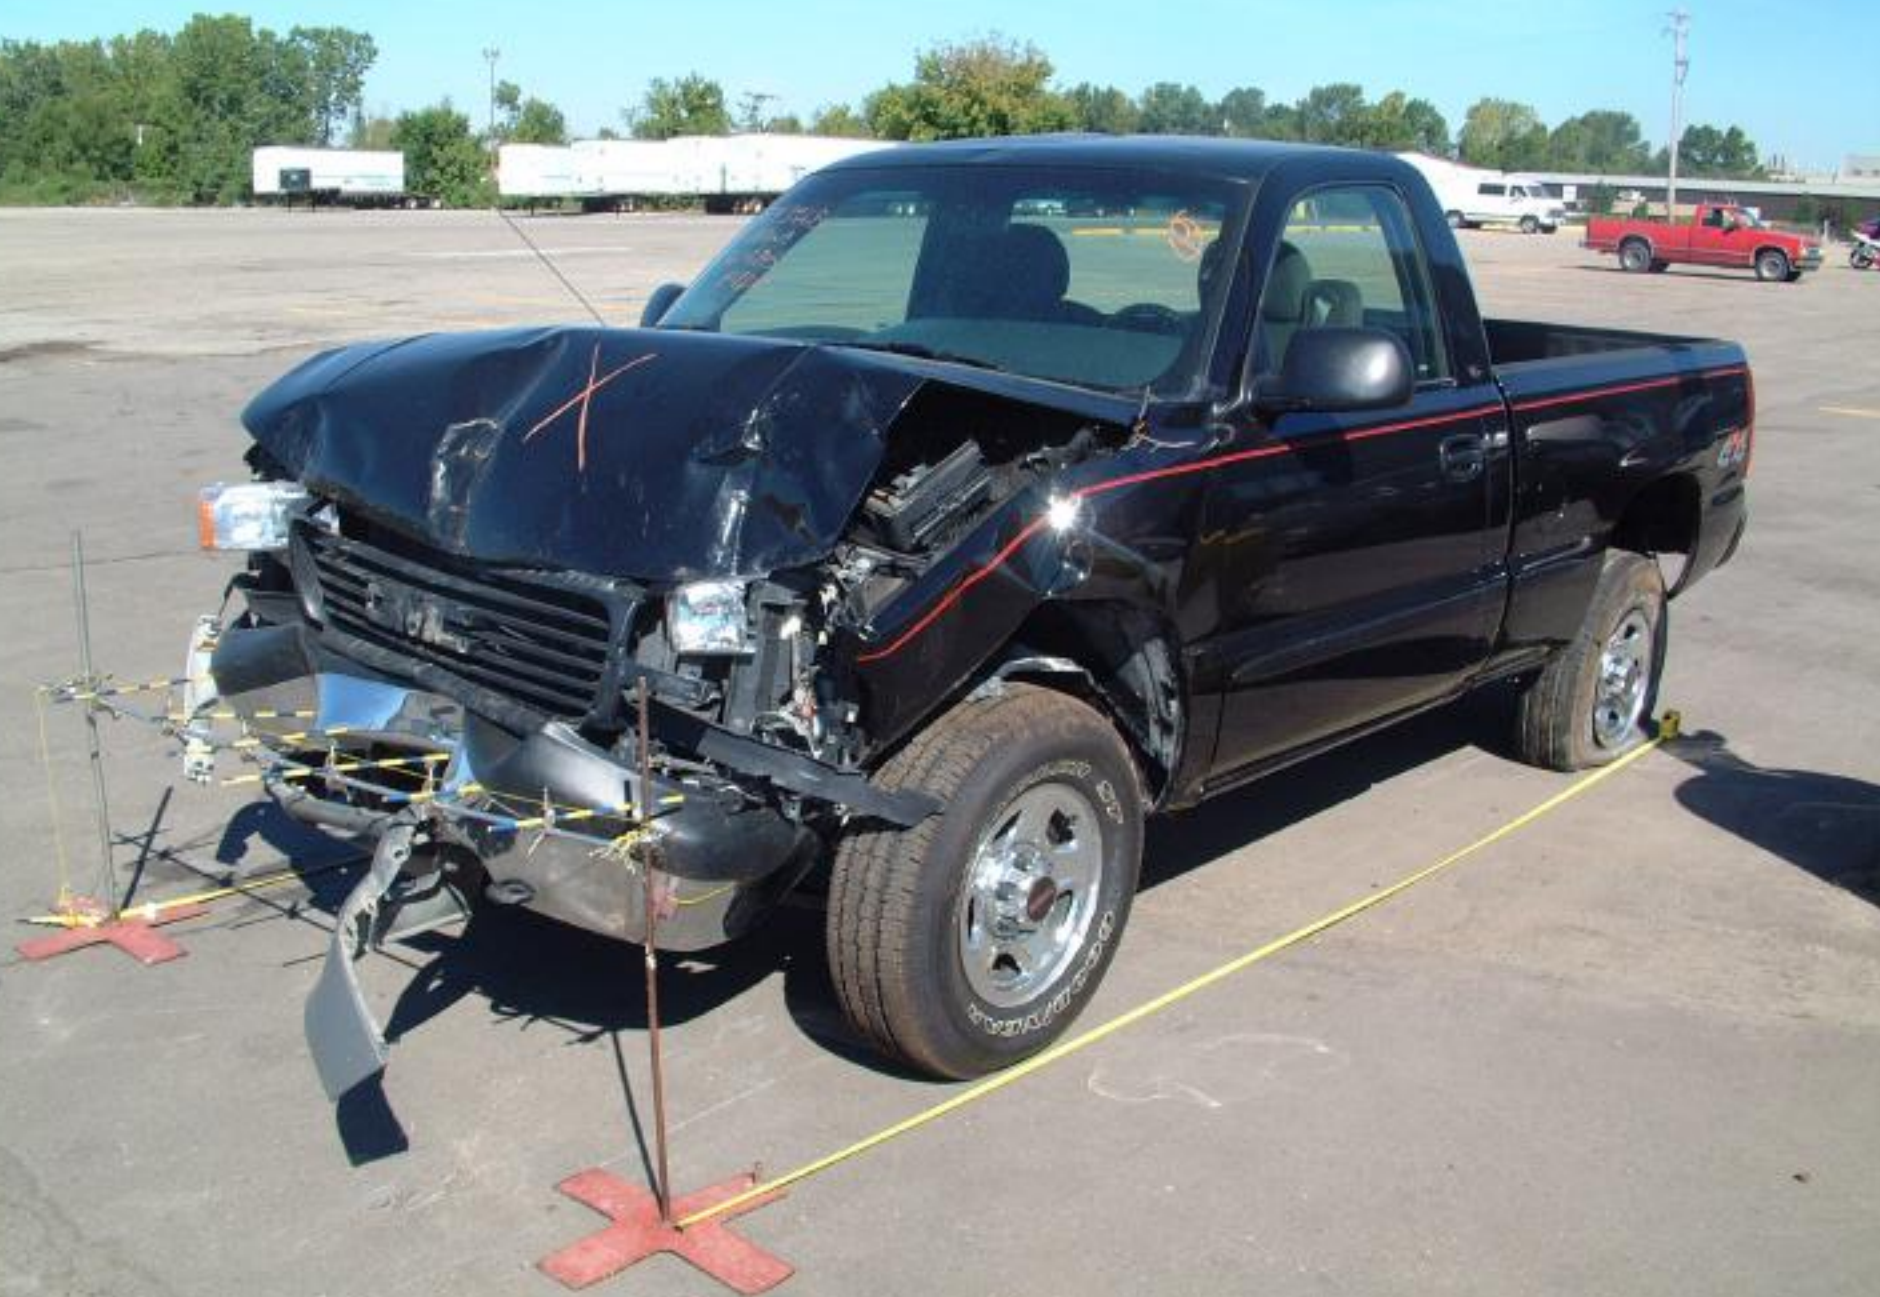
[23](#) [24](#) [25](#) On the right side, the forward portion of the right fender was slightly deformed, but there was no significant change in the right wheelbase. There was no damage to the right-side glazing. The right door was closed and operational.

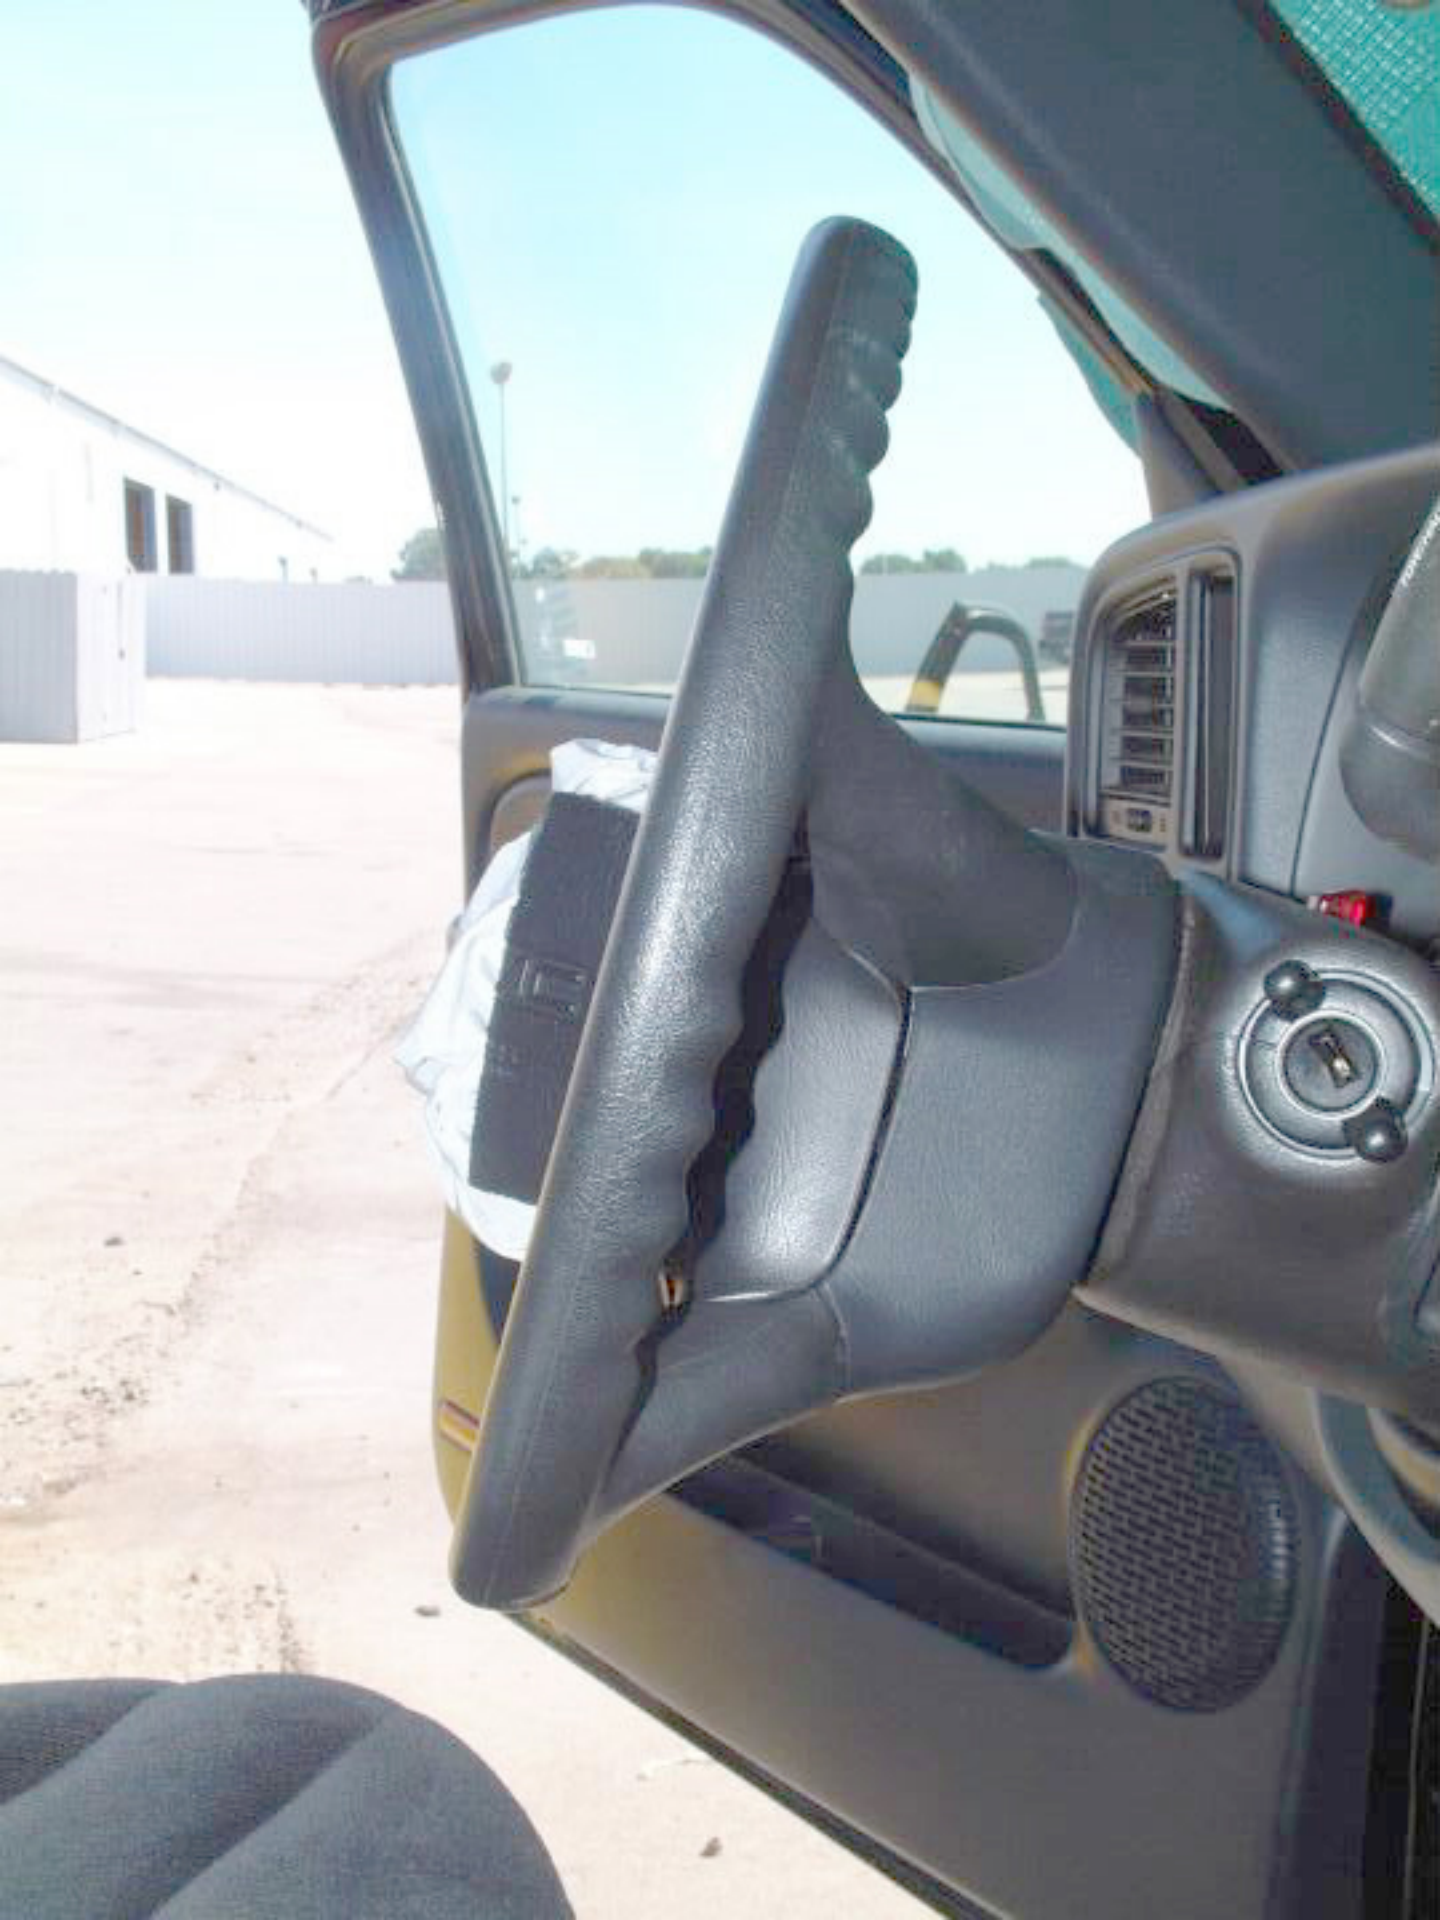
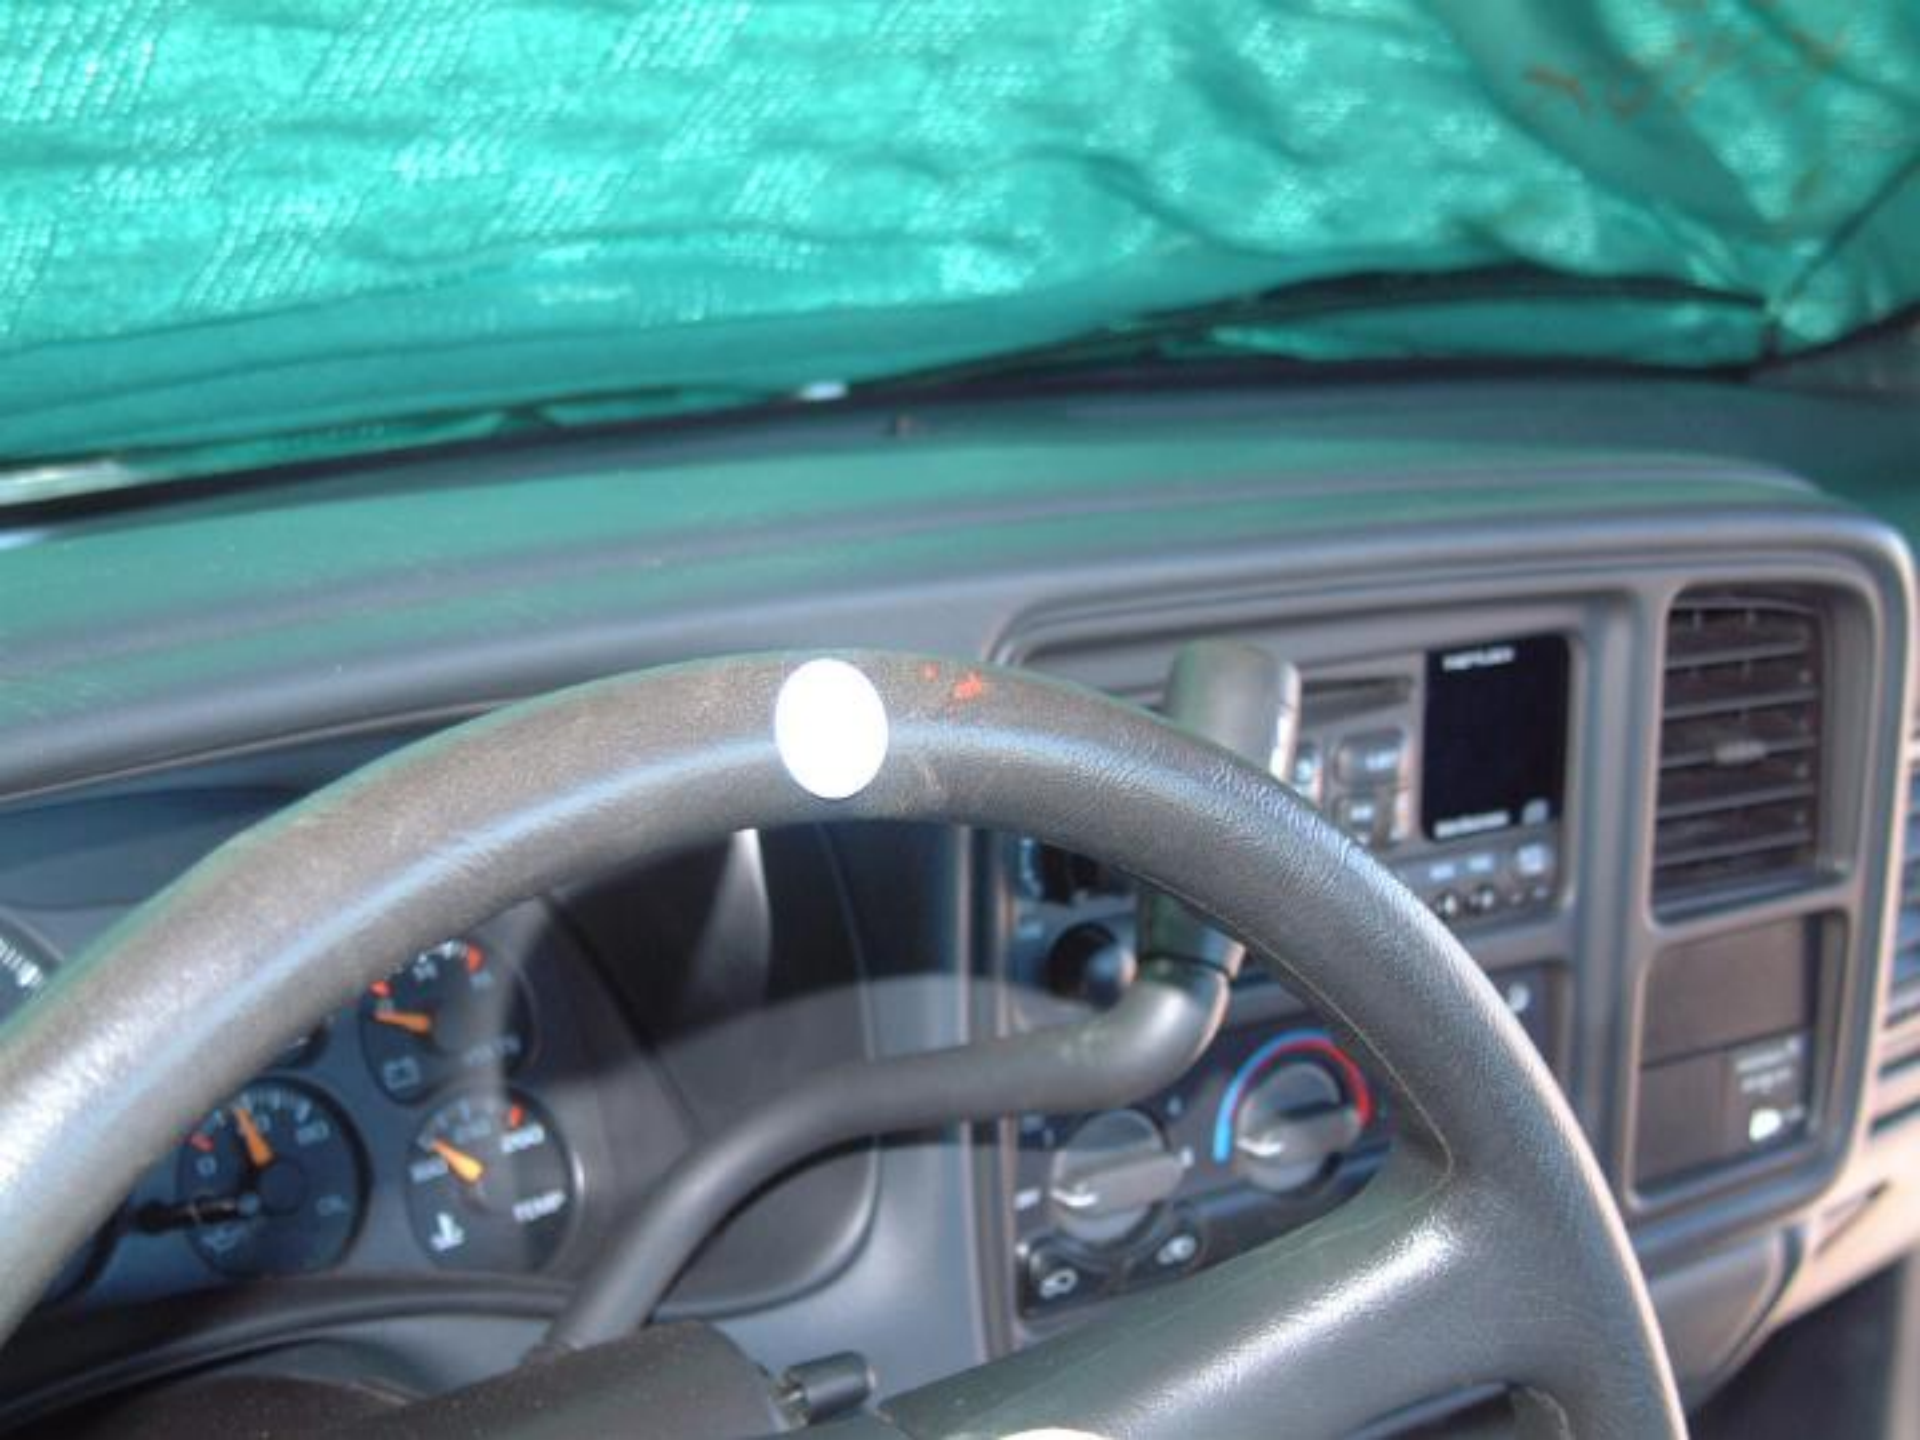
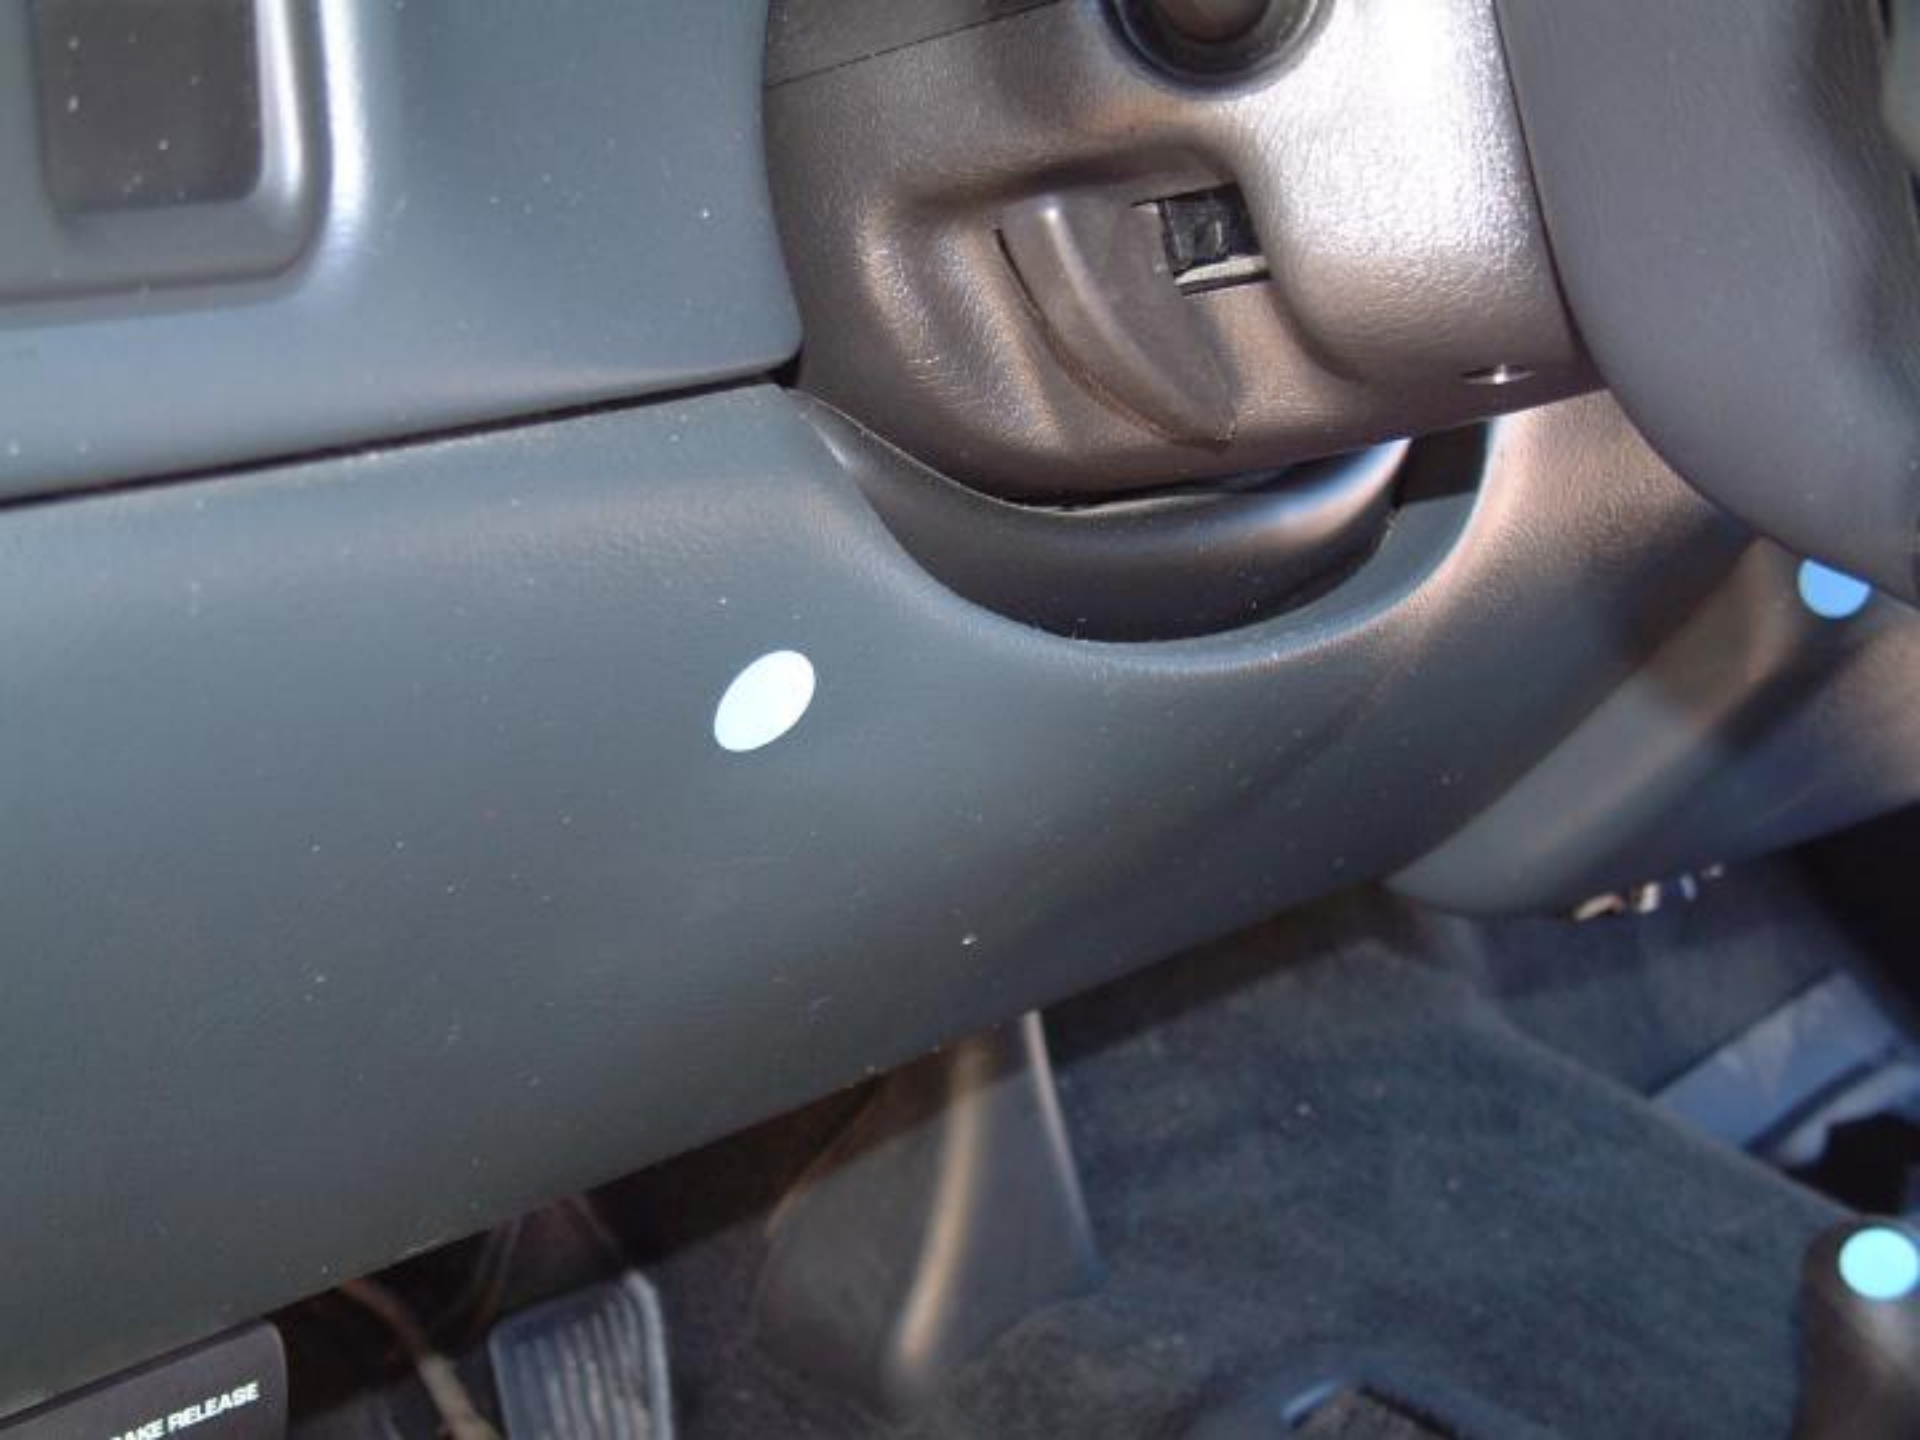
[51](#) The 21-year-old male driver was using the seat-integrated three-point belt [52](#) and the frontal-impact airbag deployed. [53](#) There were witness marks on the plastic shoulder-belt guide and [54](#) [55](#) sliding latchplate, indicating belt use at the time of the crash.
